Aircraft Accident Investigation Bureau of Myanmar

**FINAL REPORT OF HARD LANDING INCIDENT OF AIR MANDALAY AIRLINES
EMBRAER-145EP IN SITTWE AIRPORT ON 18th SEPTEMBER, 2017**

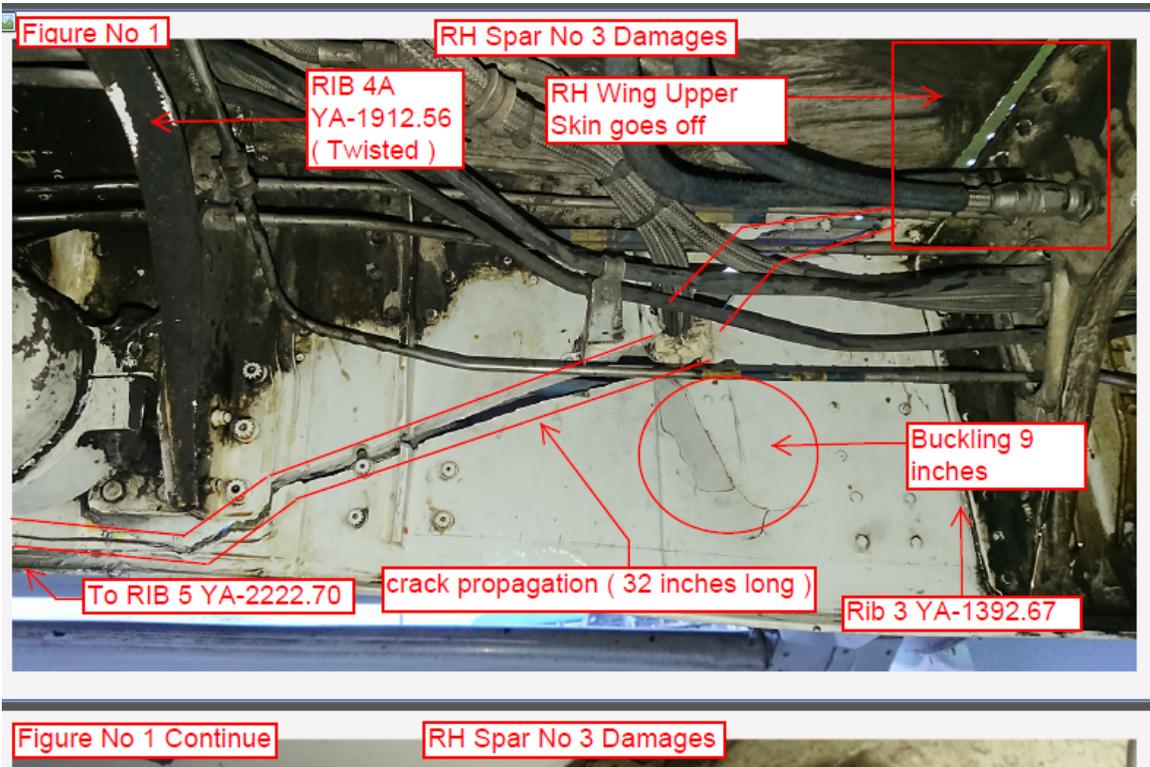
1.3.1 Right Hand Wing, Spar No 3 broken

- (a) Crack propagation from (RIB 3A YA-1392.67 up to RIB 5 YA-2222.70)
- (b) Length of crack is 32 inches.
- (c) Nature of crack is diagonal across the SPAR No 3
- (d) Refer to Figure no.1

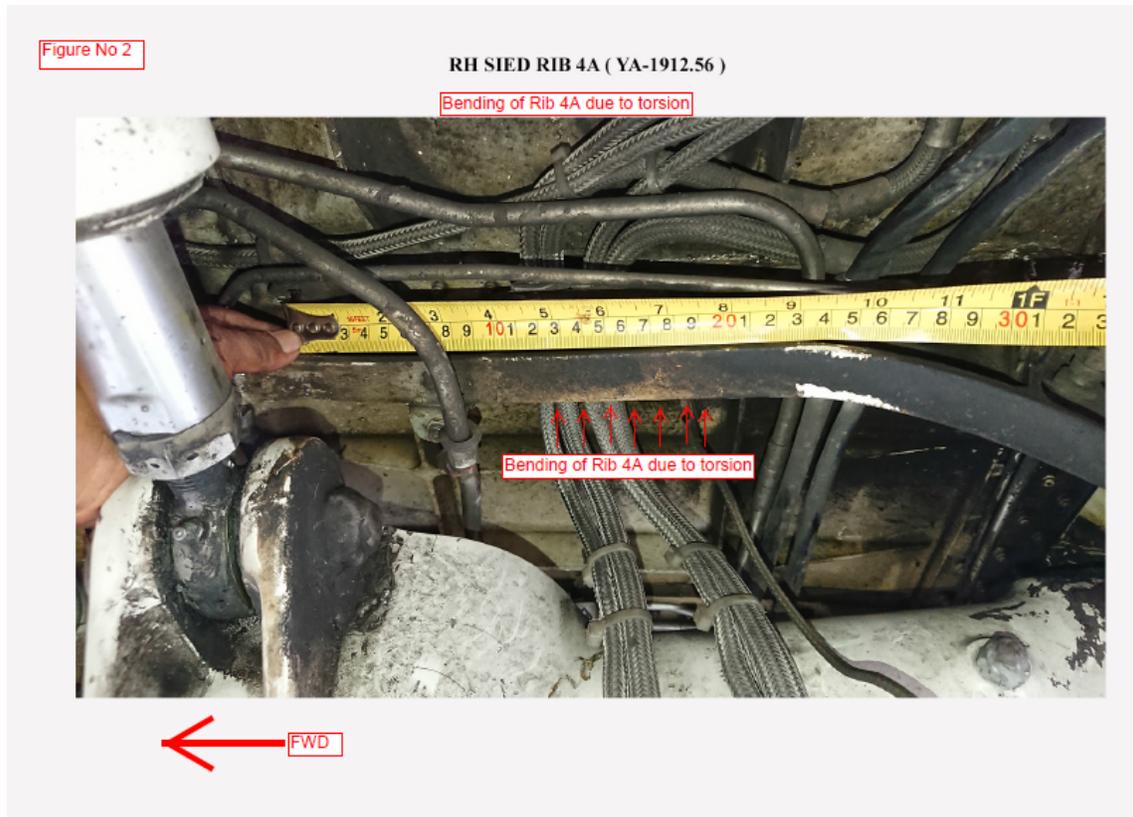
1.3.2 RIB 4A twisted or deformed

- (a) The length twist is about 9 cm
- (b) Refer to Figure no.2

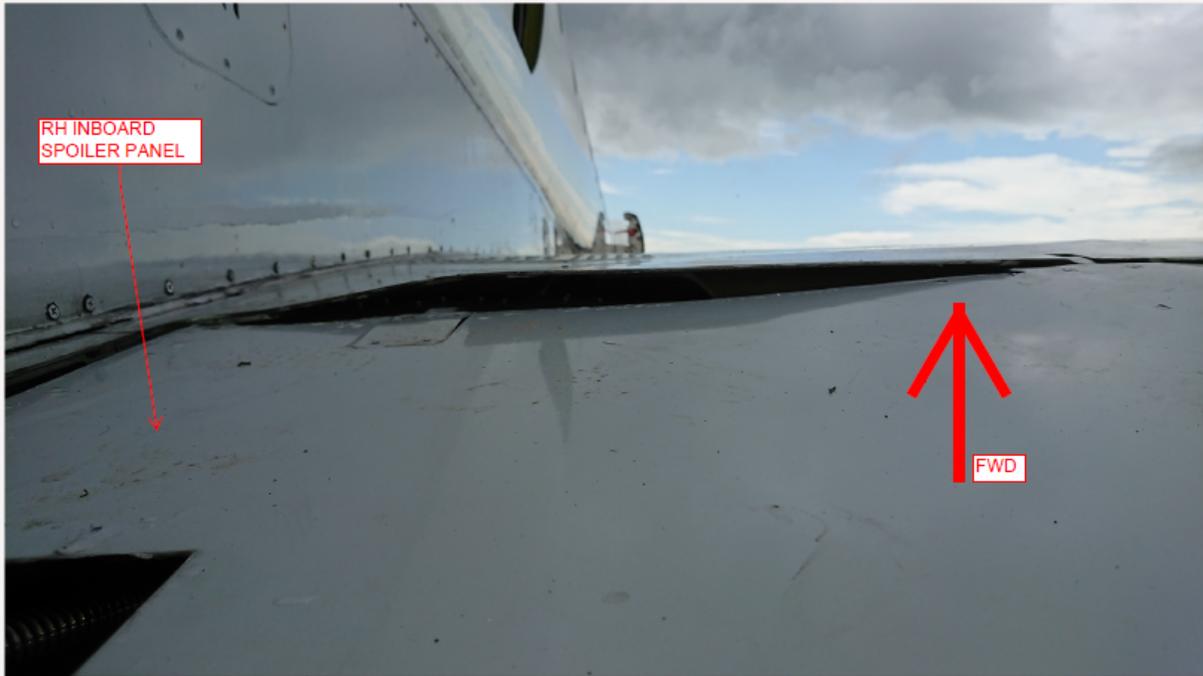
FIGURE NO 3

1.3.3 Right Hand Wing Skin at Trailing Edge Separation

- (a) Location is between Y-1085.00 to RIB 4A YA-1912.56
- (b) Fasteners to RIB 3 and Spar No 3 went off
- (c) Length of Skin Separation (61 cm long).
- (d) Peak of buckle is about 3 cm high.
- (e) Refer to Figure no.3

RH Wing, Trailing Edge Skin Buckling (From Y - 1085.50 + 61 cm)

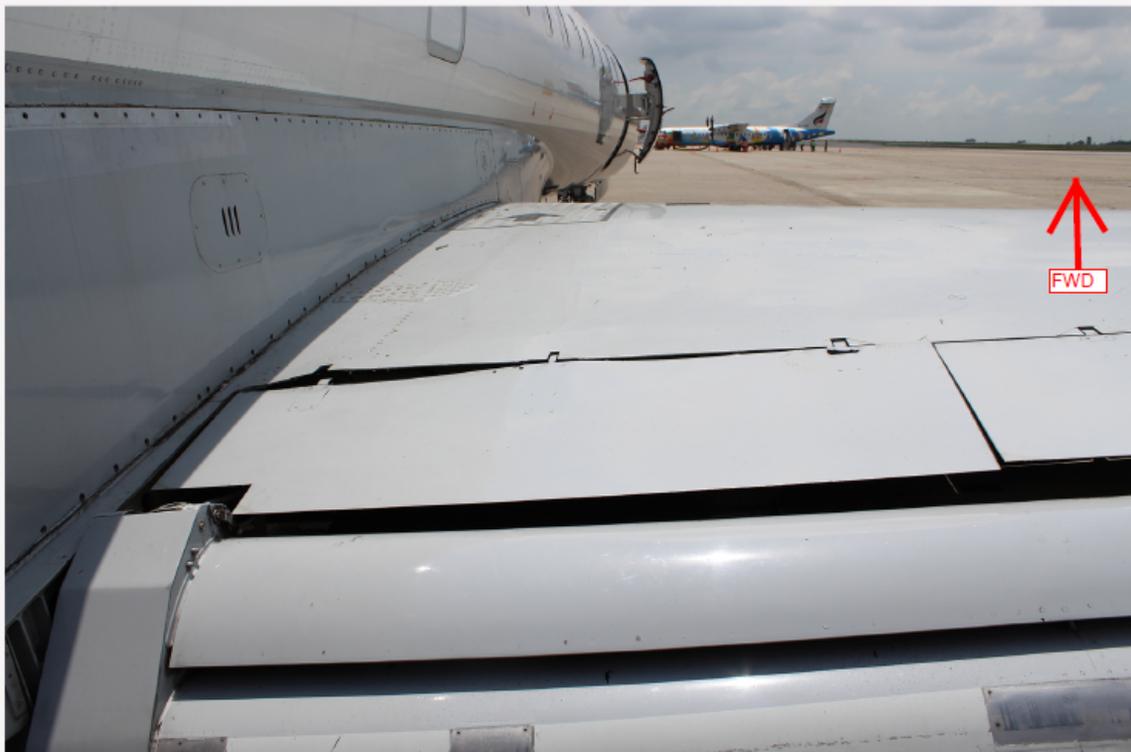
Figure No 4

1.3.4 Buckling of Right Hand Wing Inboard Spoiler

- (a) Spoiler Panel buckling (Length is about 128 cm in wave form)
- (b) Refer to figure no.4

Damages and skin Buckling of RH Inboard Spoiler Panel

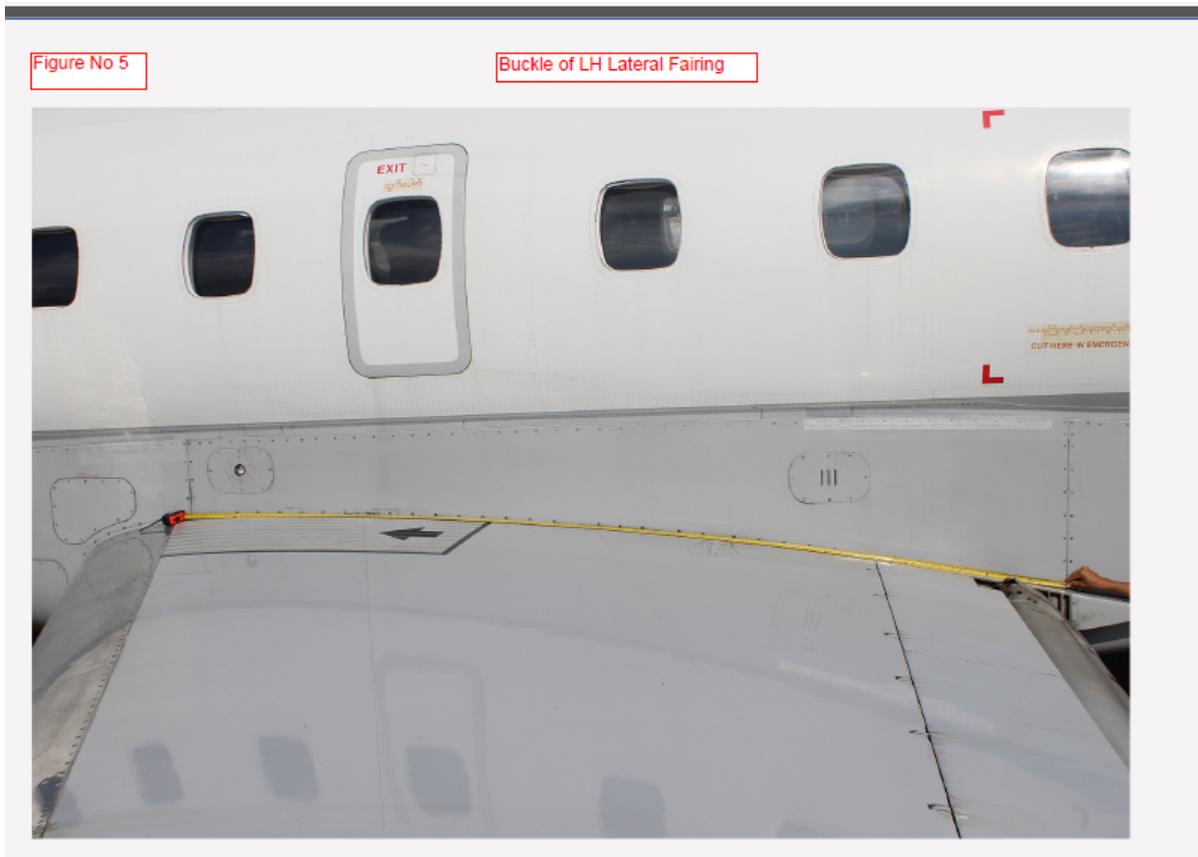
1.3.5 Deformation of LH Side lateral fairing, (Location: Central Fuselage)

- (a) Fiber glass panel buckled (Length 180 cm)
- (b) Refer to Figure no.5
