**FINAL REPORT OF RUNWAY INCURSION OF  
SINGAPORE AIRLINES, B737-8 AIRCRAFT  
(9V-MBG) THAT OCCURRED  
AT YANGON INTERNATIONAL AIRPORT,  
ON 25<sup>th</sup> OCTOBER, 2023**

**MYANMAR TRANSPORT SAFETY BRANCH  
MINISTRY OF TRANSPORT AND COMMUNICATIONS**

**25 April 2024**

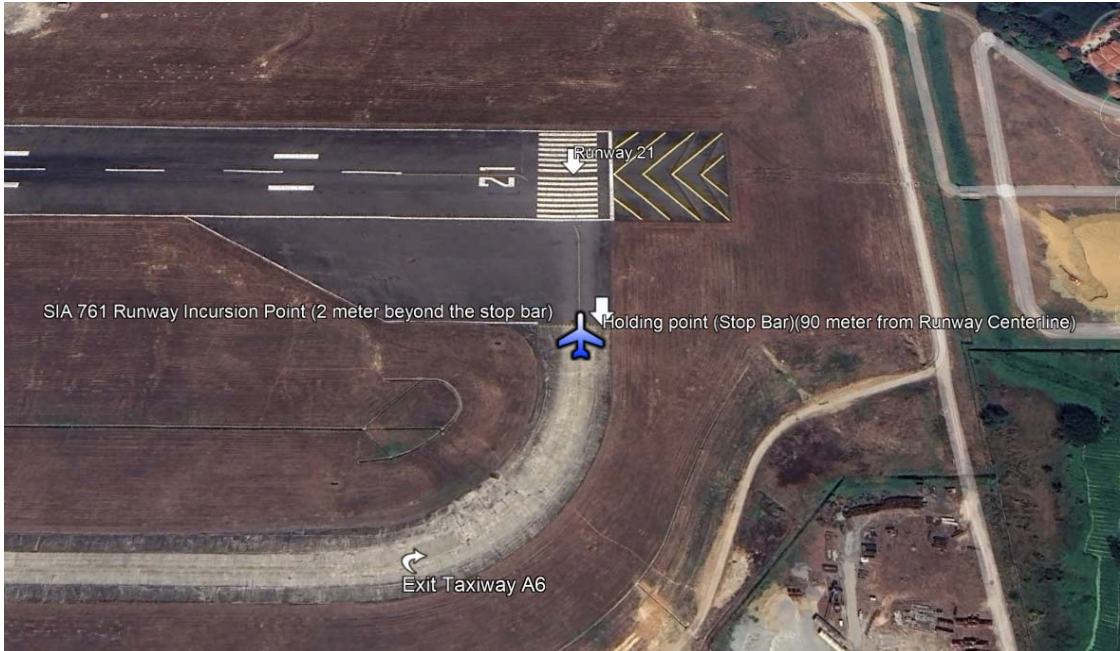
**Figure (1) Layout of SIA 761 Incident Site**

This resulted in a runway incursion. No one was injured in this incident. The pilot flying estimated that the aircraft nose might be up to 2 meter beyond the stop bar by the time the aircraft came to a stop. (See Figure 1 and 2)

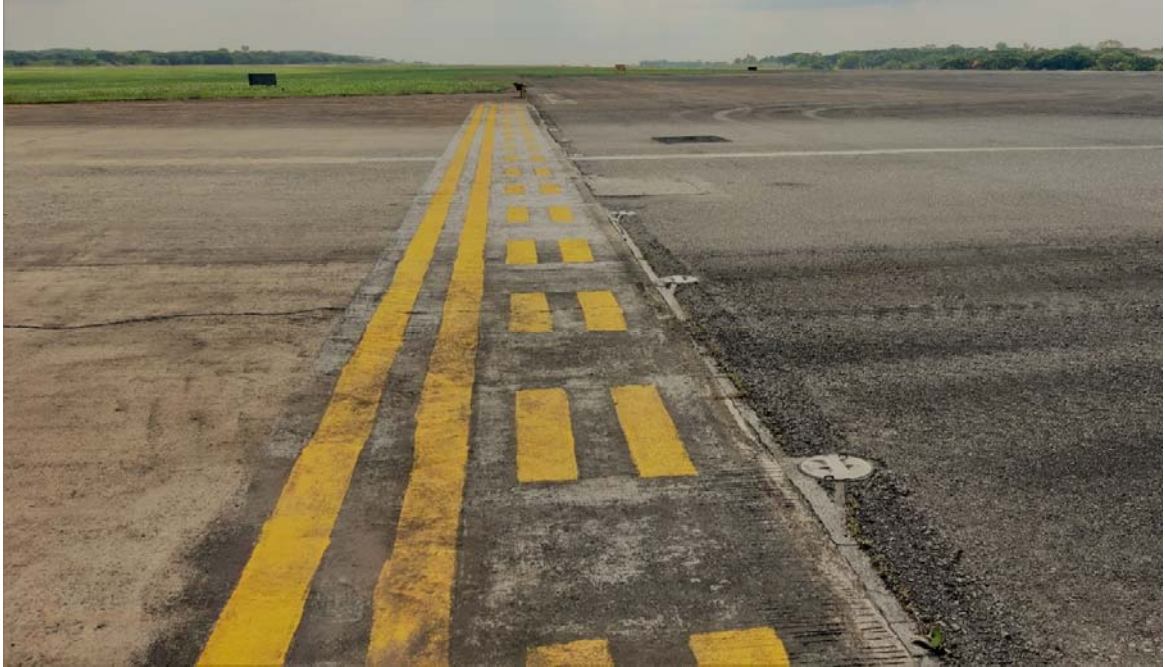
**Figure (3) Runway Holding Position Marking and Stop bar Lights of Taxiway A6**

In this incident, the red stop bar lights and runway guard lights were serviceable and all the markings at the holding position were visible. There were no reported faults as regards the red stop bar lights.
