FINAL REPORT
FOKKER F-28 MK 0100, XY-AGC
ACCIDENT NEAR HEHO AIRPORT (VYHH)
ON 25 DECEMBER 2012

FOKKER F-28 MK 0100, XY-AGC **ACCIDENT NEAR HEHO AIRPORT (VYHH)** **ON 25 DECEMBER 2012**

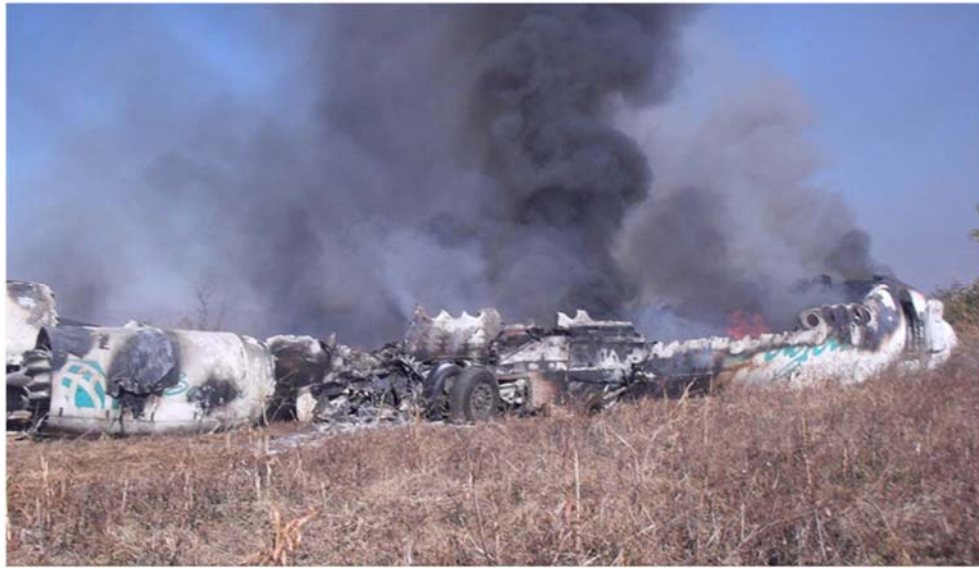
Figure 4: Damage to Aircraft

Both wings had separated before the aircraft came to rest. The main fuselage, both engines and the landing gear remained together. The tail assembly had detached but remained connected to the fuselage by the flight control cables. The remainder of the aircraft was subsequently destroyed by fire.

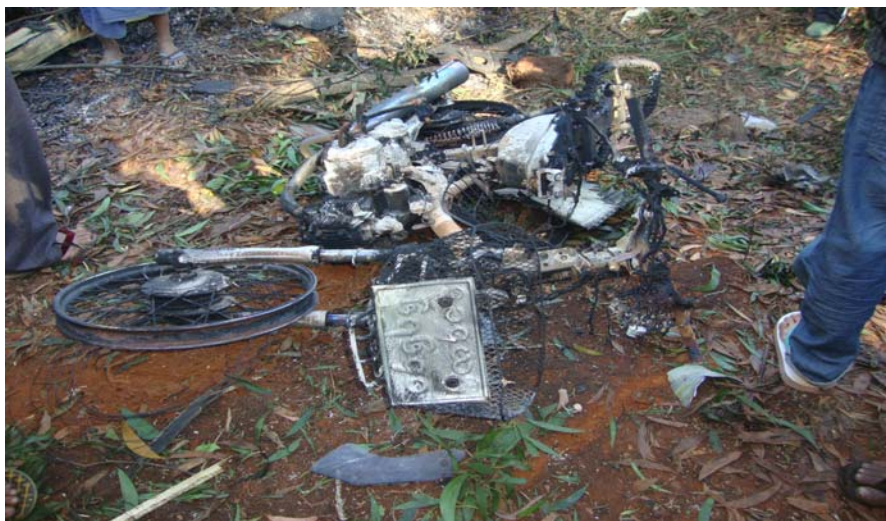
Figure 5 : Damage to motorcycle

There was other damage to a 66 KV power lines, trees, 11 KV power lines, telephone cables, a fence and a motorcycle. As the aircraft struck the trees, a motorcycle with two motorcyclists passing on the road, aircraft debris struck the motorcycle. The motorcycle was destroyed.
