## FINAL REPORT OF RUNWAY EXCURSION OF MYANMAR NATIONAL AIRLINES, ATR 72-600 AIRCRAFT (XY-AME) AT YANGON INTERNATIONAL AIRPORT, ON 17<sup>th</sup> NOVEMBER, 2022

# Myanmar Transport Safety Branch Ministry of Transport and Communications Myanmar

2 August 2023

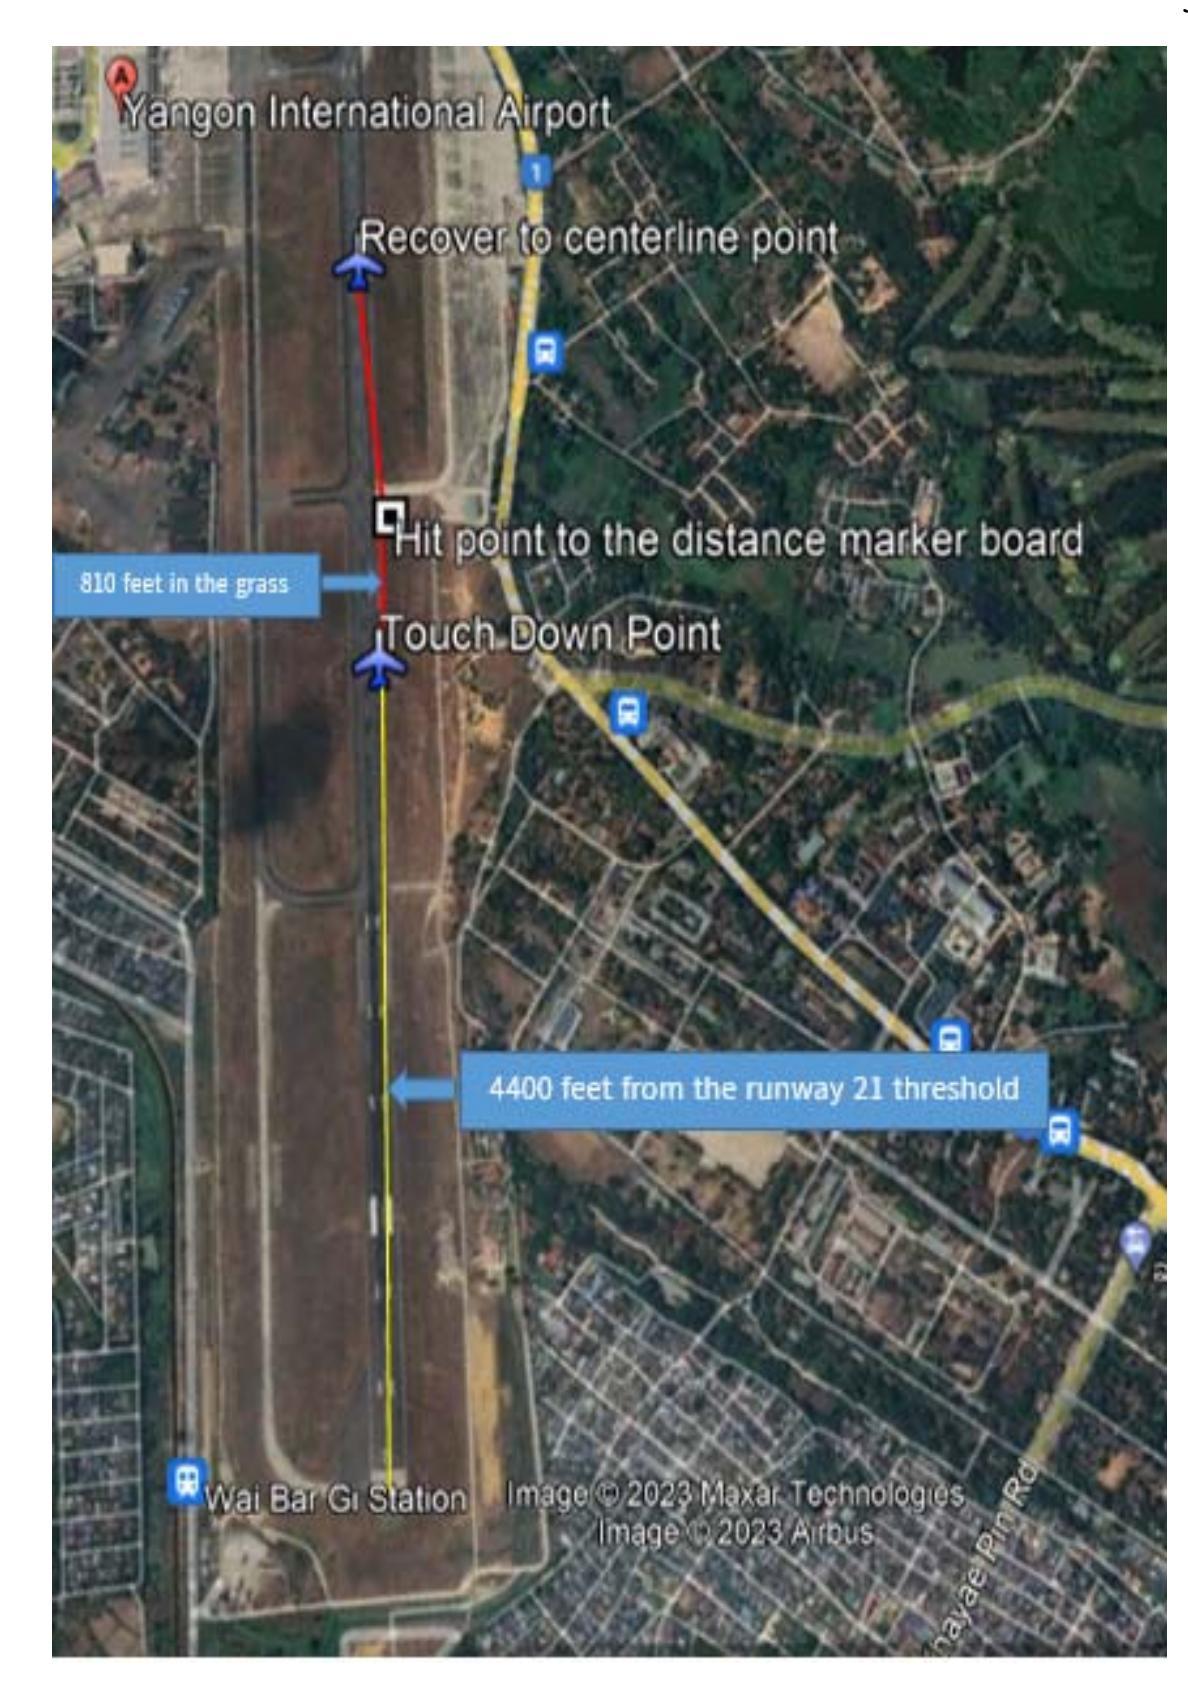
The aircraft landed on the right side of the runway about 37 feet from the runway centerline pointing to the right and about 4400 feet from the runway 21 threshold. And then the aircraft veered slightly to the right and exited the pave runway and continued parallel with the runway about 810 feet on the grass turf and collided with the runway distance maker board No. (6/5) where was installed on the right side of runway shoulder. After that the flight crew managed to steer the aircraft back to the runway centerline about 200 feet before the exit taxiway B3 and continued taxiing and came to a complete stop at parking bay No.13 without any further incident. The ground path of the aircraft was according to the accident site inspection and measurement by MTSB investigators. See figure (1).

Figure (1) Ground path of the aircraft

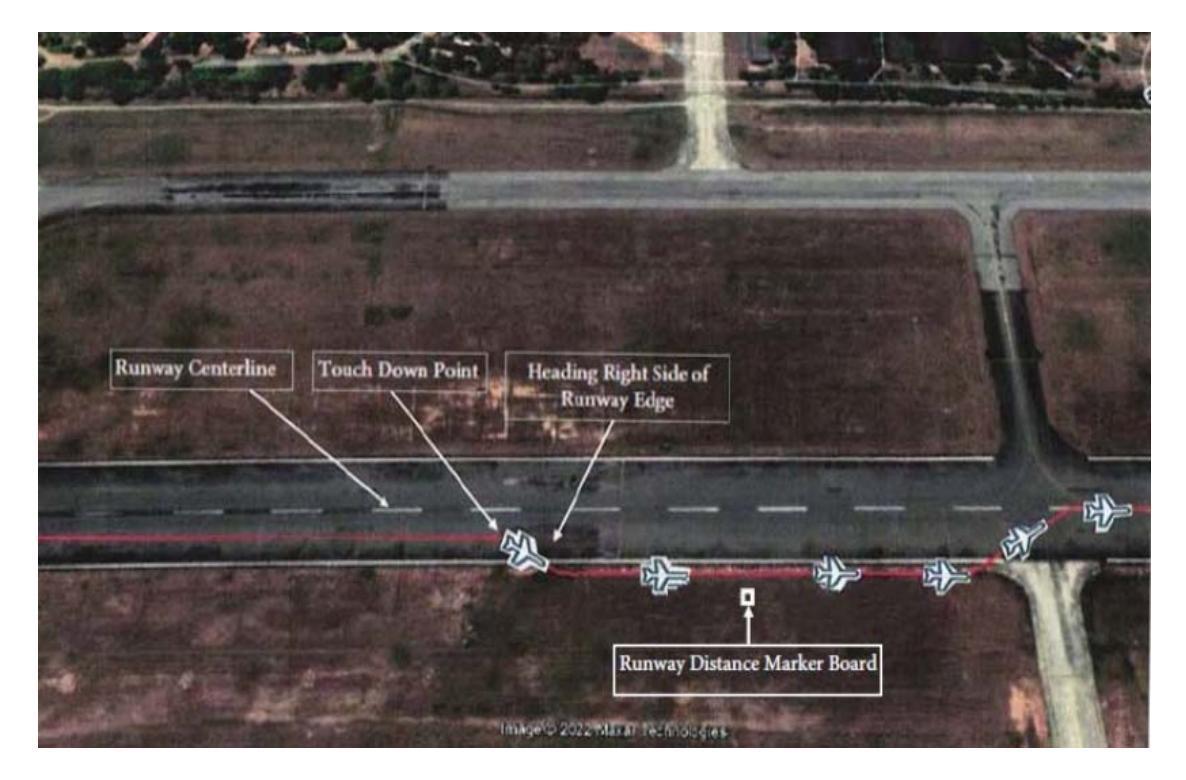
Figure (2) Layout of Accident Site

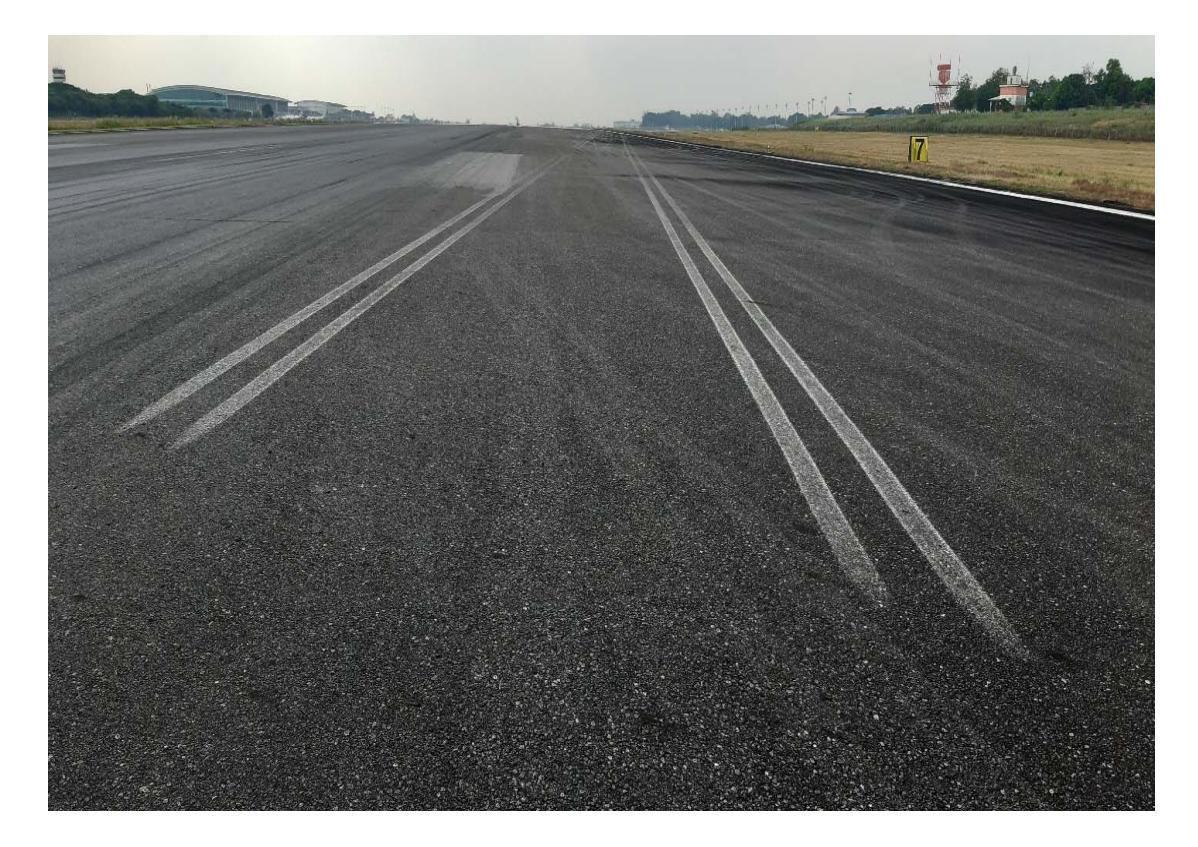
Figure (3) The Wheel Impact Marks on the runway

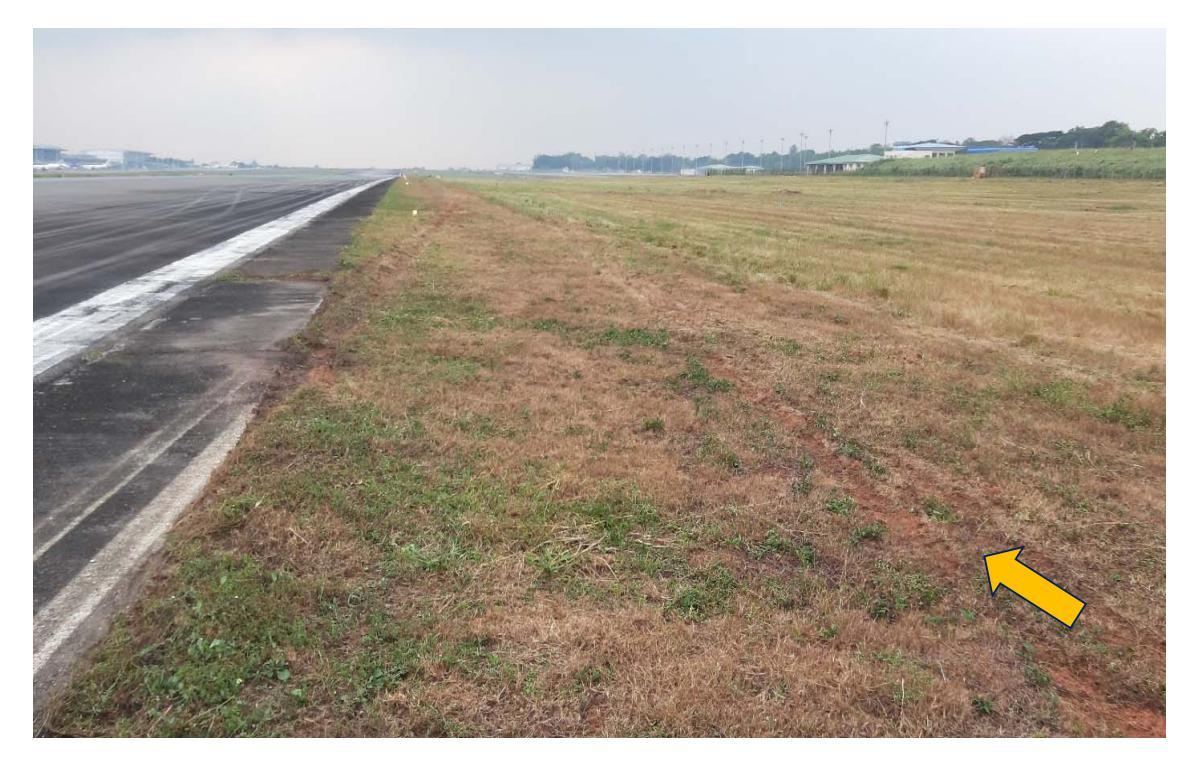
Figure (4) The Wheel Impact Marks along the right side of runway shoulder

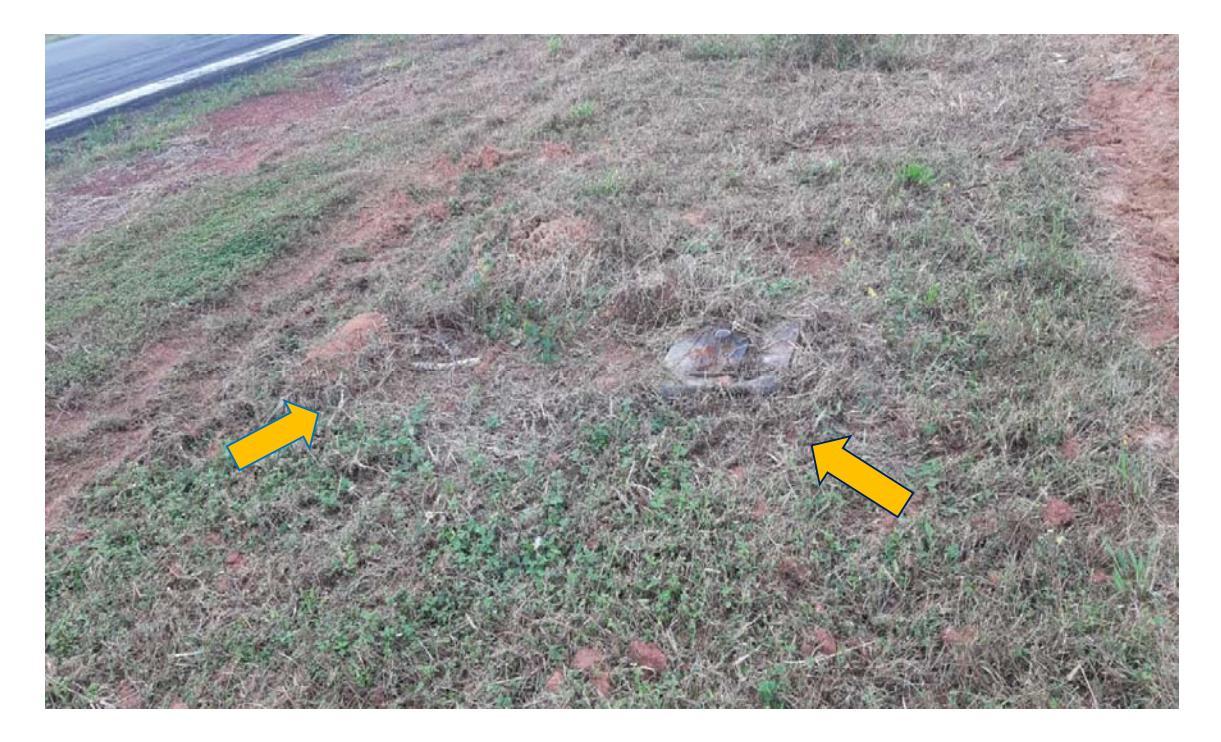
Figure (5) Location of the runway distance marker board No.(6/5)

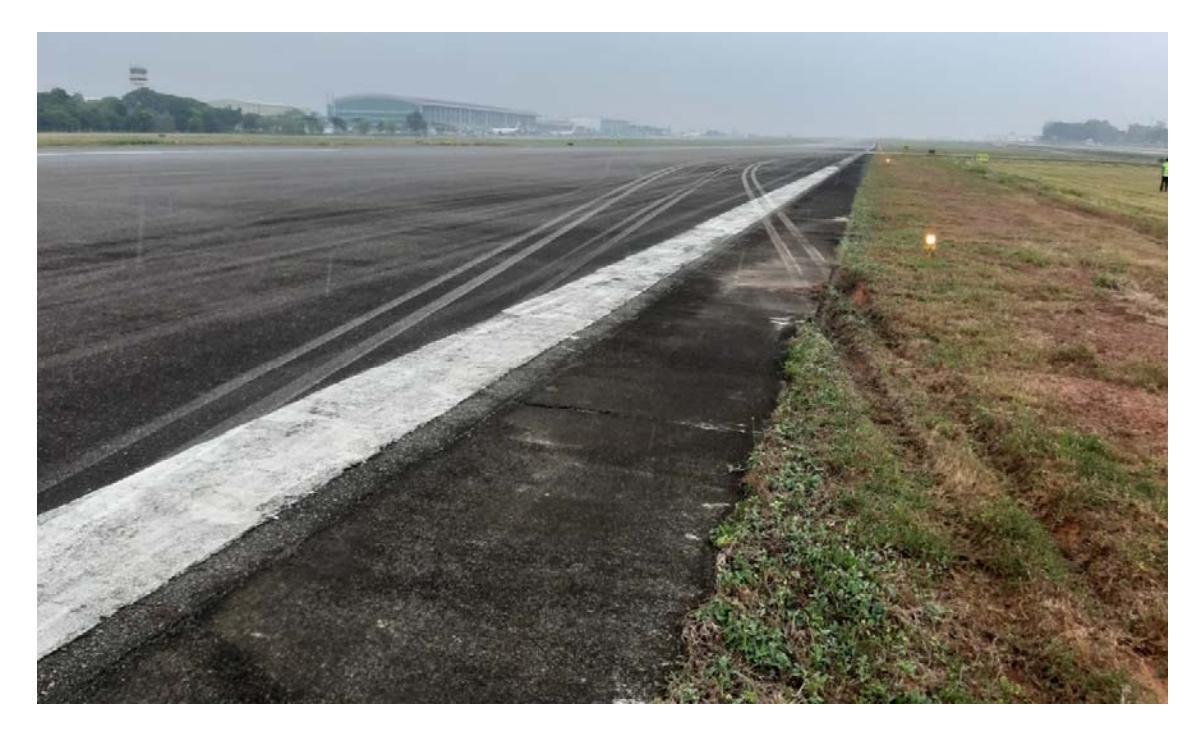
Figure (6) The Wheel Impact Marks at which the aircraft returned to the runway centerline

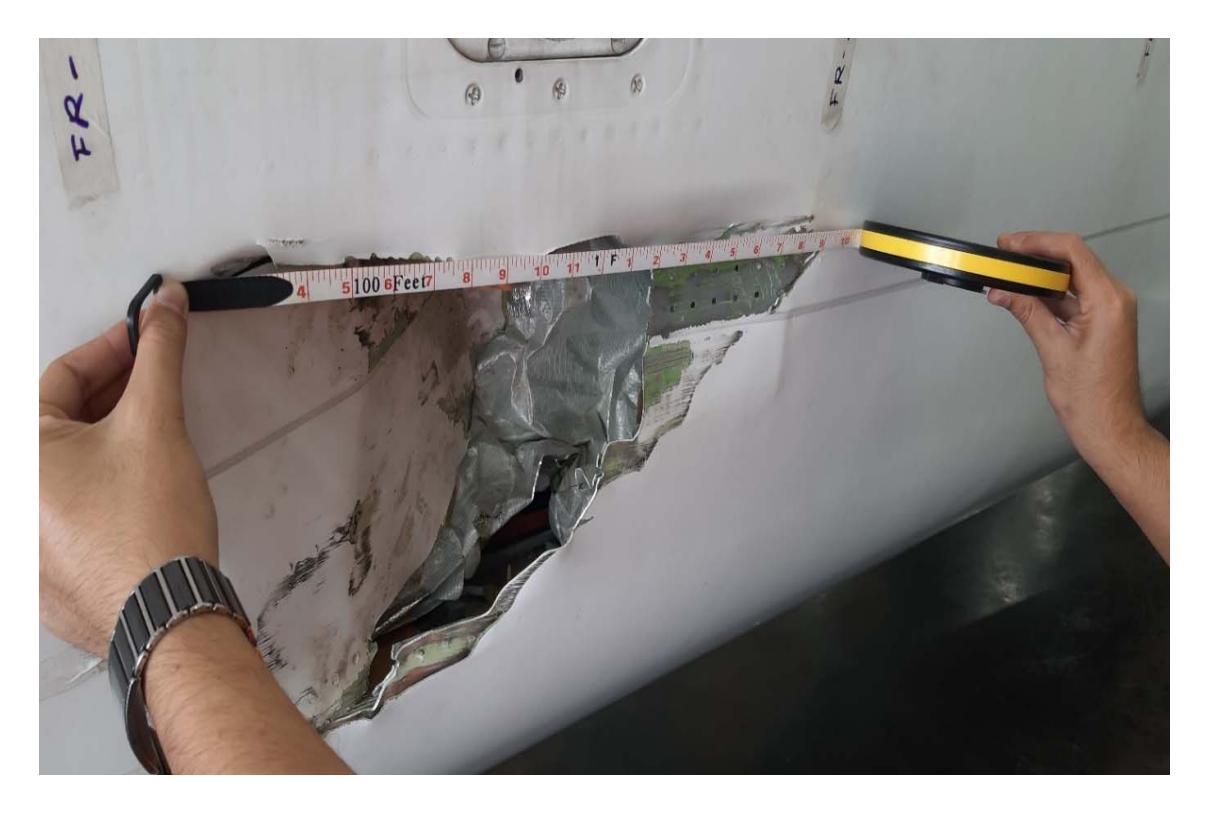
(a) Aircraft right fuselage skin (between frame No.20 and 21) was torn as a triangular shape and the rupture of fuselage skin was about 22 inches long, 22 inches wide and 12 inches height. See figure (7)

Figure (7) Damage to the aircraft right fuselage skin

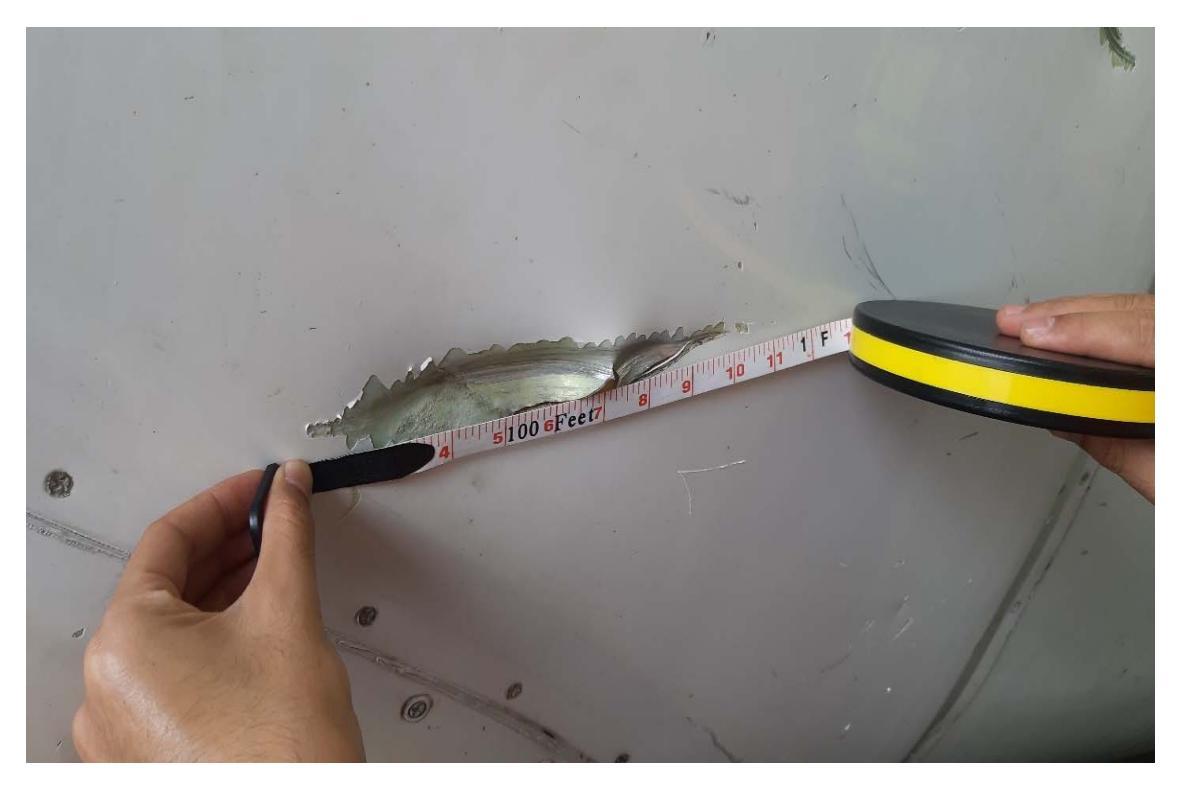
- (b) Aircraft right fuselage skin near the emergency exit door (between structure No.17,18 and frame No.23 A) was torn about 10 inches. See figure (8)
- (c) Aircraft fuselage skin under the belly was torn about 12 inches horizontally and transversely. See figure (9)
- (d) Aircraft left fuselage skin, frame No.25 and left main landing gear door hinge were damaged. See figure (10) and (11)
- (e) Air-condition pack intake area of the aircraft was torn and damaged. See figure (12)
- (f) Aircraft landing light cover was damaged. See figure (13)

Figure (8) Damage to the aircraft right fuselage skin near the emergency exit door

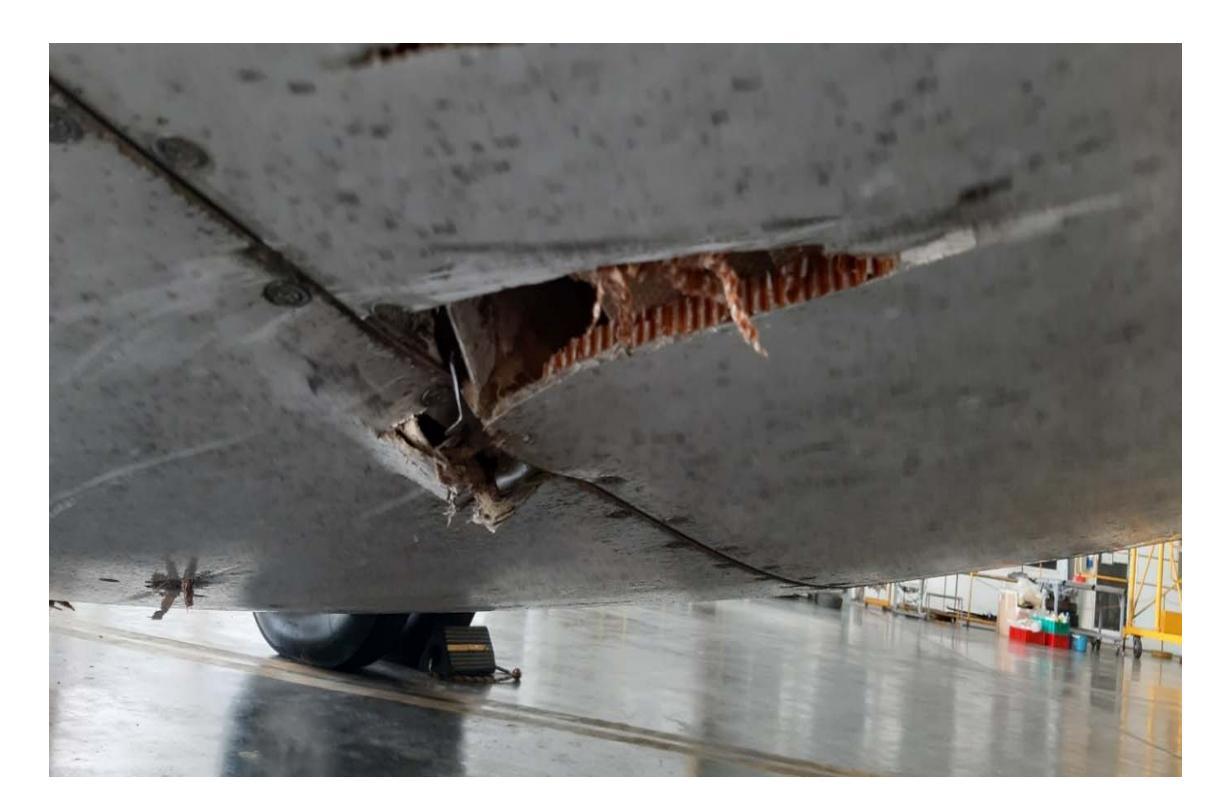
Figure (9) Damage to the aircraft fuselage skin on the belly

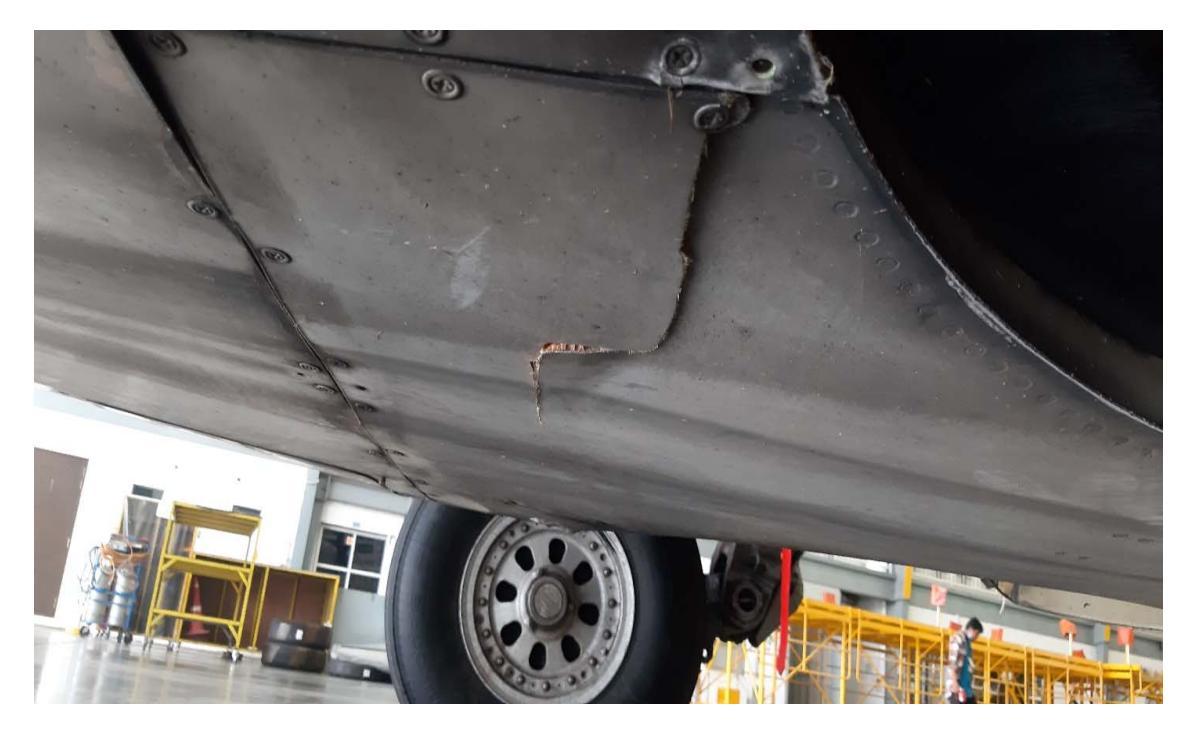
Figure (10) Damage to the aircraft fuselage skin on the belly

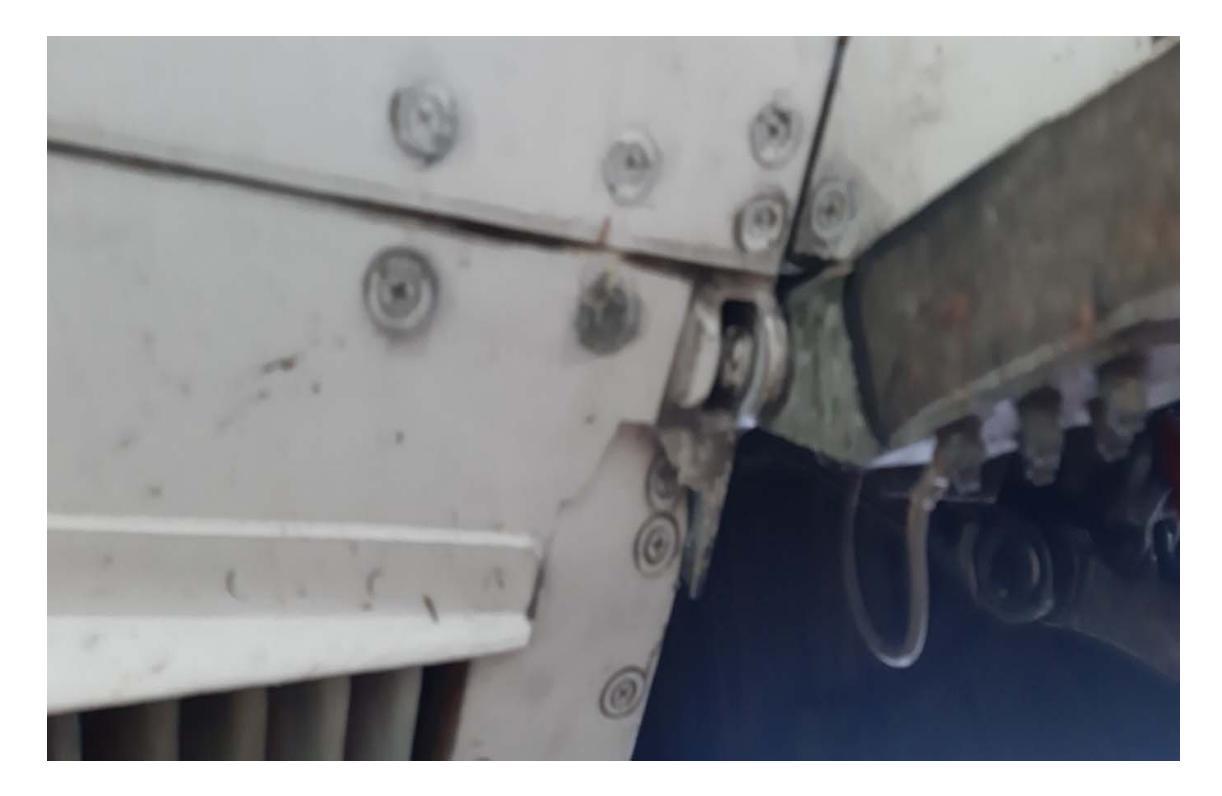
Figure (11) Damage to the left main landing gear door hinge

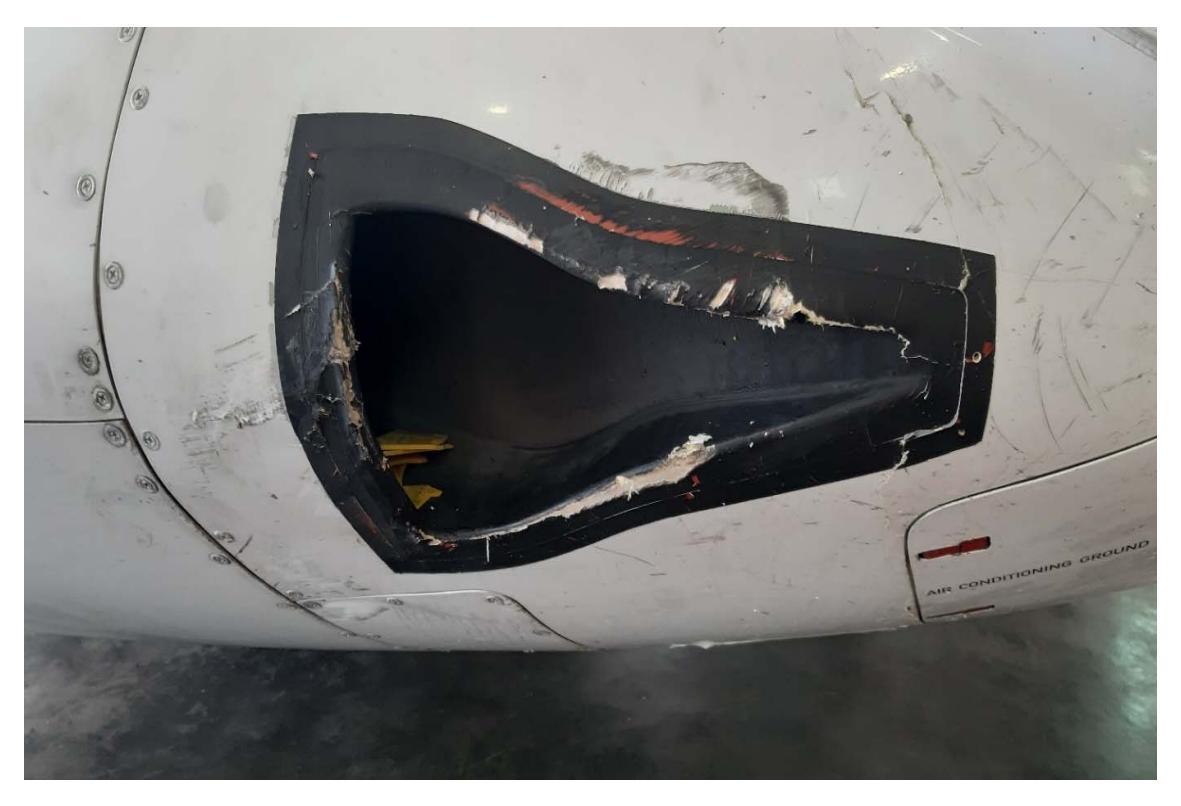
Figure (12) Damage to the air-condition pack intake area

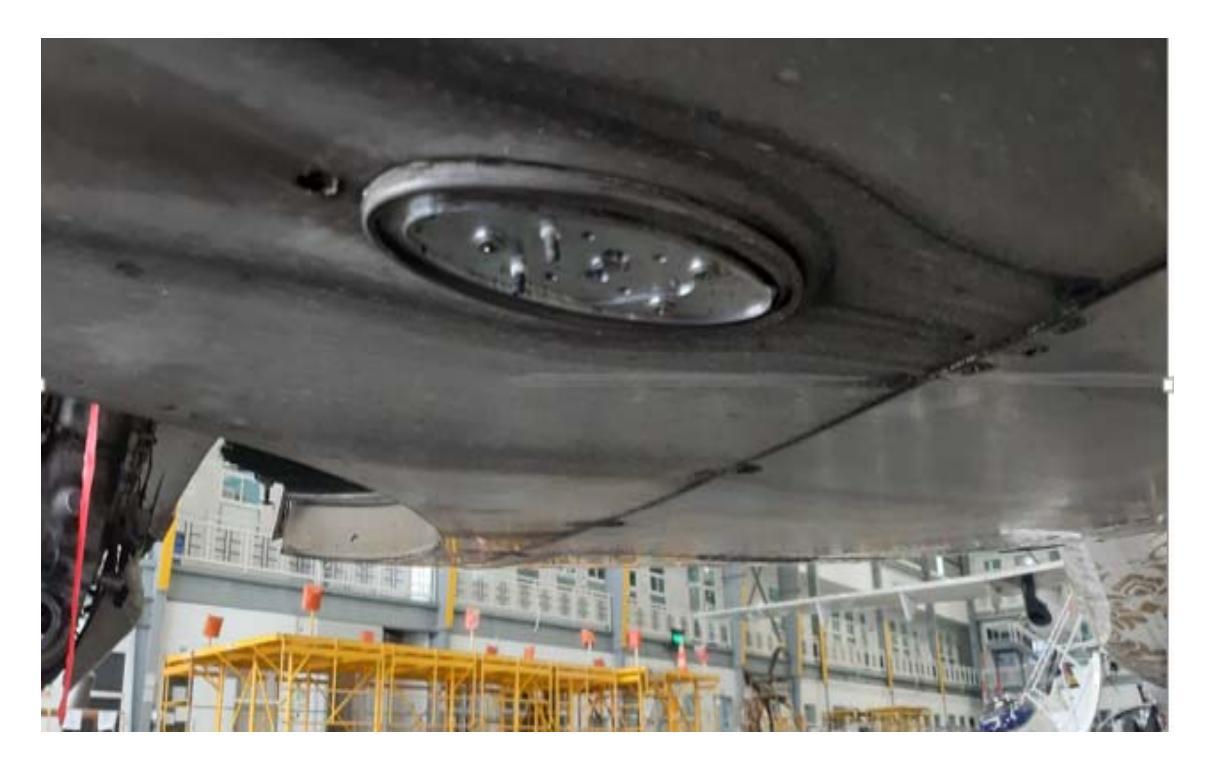
Figure (13) Damage to the landing light cover

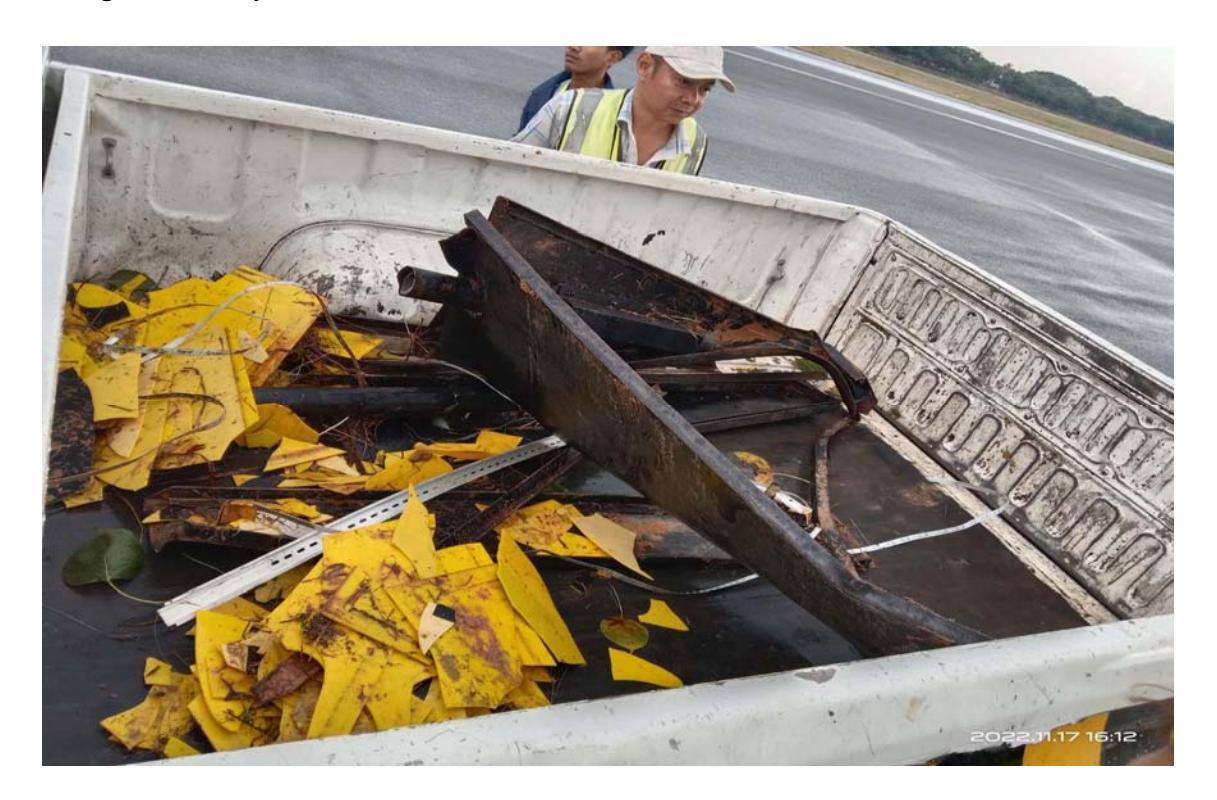
Runway Distance Marker Board No.(6/5) was damaged due to the aircraft impact during the runway excursion.

Figure (14) Damage to the runway distance marker board No.(6/5)
