## FINAL REPORT OF RUNWAY EXCURSION OF MYANMAR NATIONAL AIRLINES, ATR 72-600 AIRCRAFT (XY-AME) AT YANGON INTERNATIONAL AIRPORT, ON 17<sup>th</sup> NOVEMBER, 2022

# Myanmar Transport Safety Branch Ministry of Transport and Communications Myanmar

2 August 2023

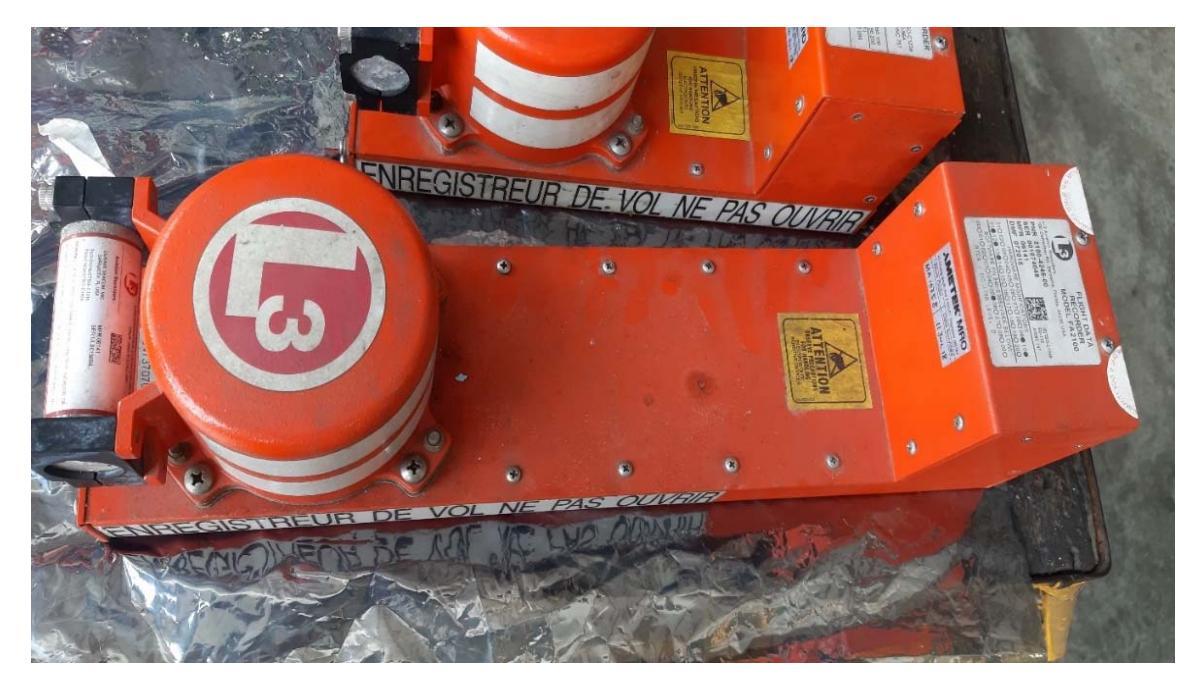
Figure (15) Flight Data Recorder

Between 14:13:43 to 14:13:48, the recorded magnetic heading increased from 188.6 degrees to 219.2 degrees, consistent with nose of aircraft rotating in the opposite direction to point towards the right edge of the runway. While the magnetic heading was passing 208.9 degrees, there was input to the rudder pedal reaching 11.8 degrees and the corresponding maximum rudder deflection was 26.8 degrees to the left.

Between 14:13:48 to 14:13:53, the final sequence of magnetic heading transition was recorded. The magnetic heading decreased from 219.2 degrees to 206.6 degrees, consistent with the aircraft nose rotating left. After this series of left-right-left rotation around the aircraft yaw axis, brake pressure of above 600 PSI was recorded on the brakes of all four wheels. Over the next 18 seconds, slight differential braking was applied (more pressure on the right wheels and less pressure on the left wheels) and by 14:14:14, the aircraft heading was 214.1 degrees, aligned with the runway heading.

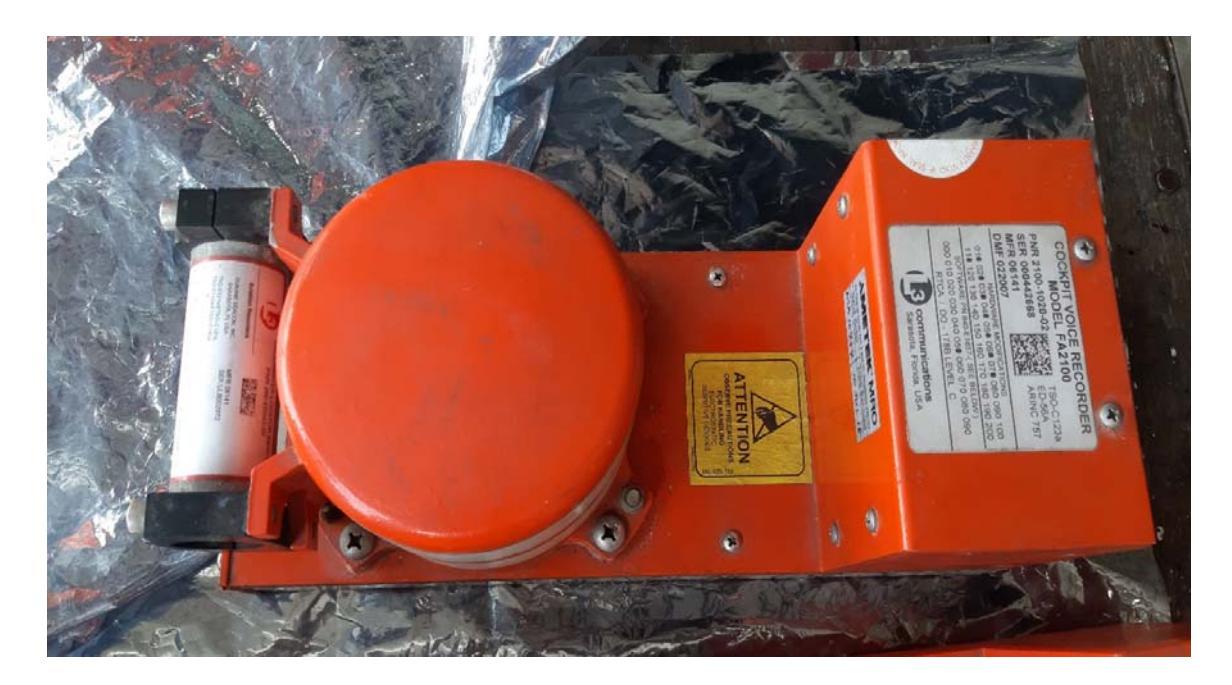
Figure (16) Cockpit Voice Recorder

The part number of Cockpit Voice Recorder (CVR) is 2100-1020-02 and the serial number is 000442668.

The CVR contained four audio tracks of duration 2 hours and 4 minutes and 14 seconds. The CVR stopped recording at 14:53:43.
